New York State Department of Transportation

PIA Safety Flag NB23U4W008

BIN: 1065318

Feature Carried: 278I278IX2M23027

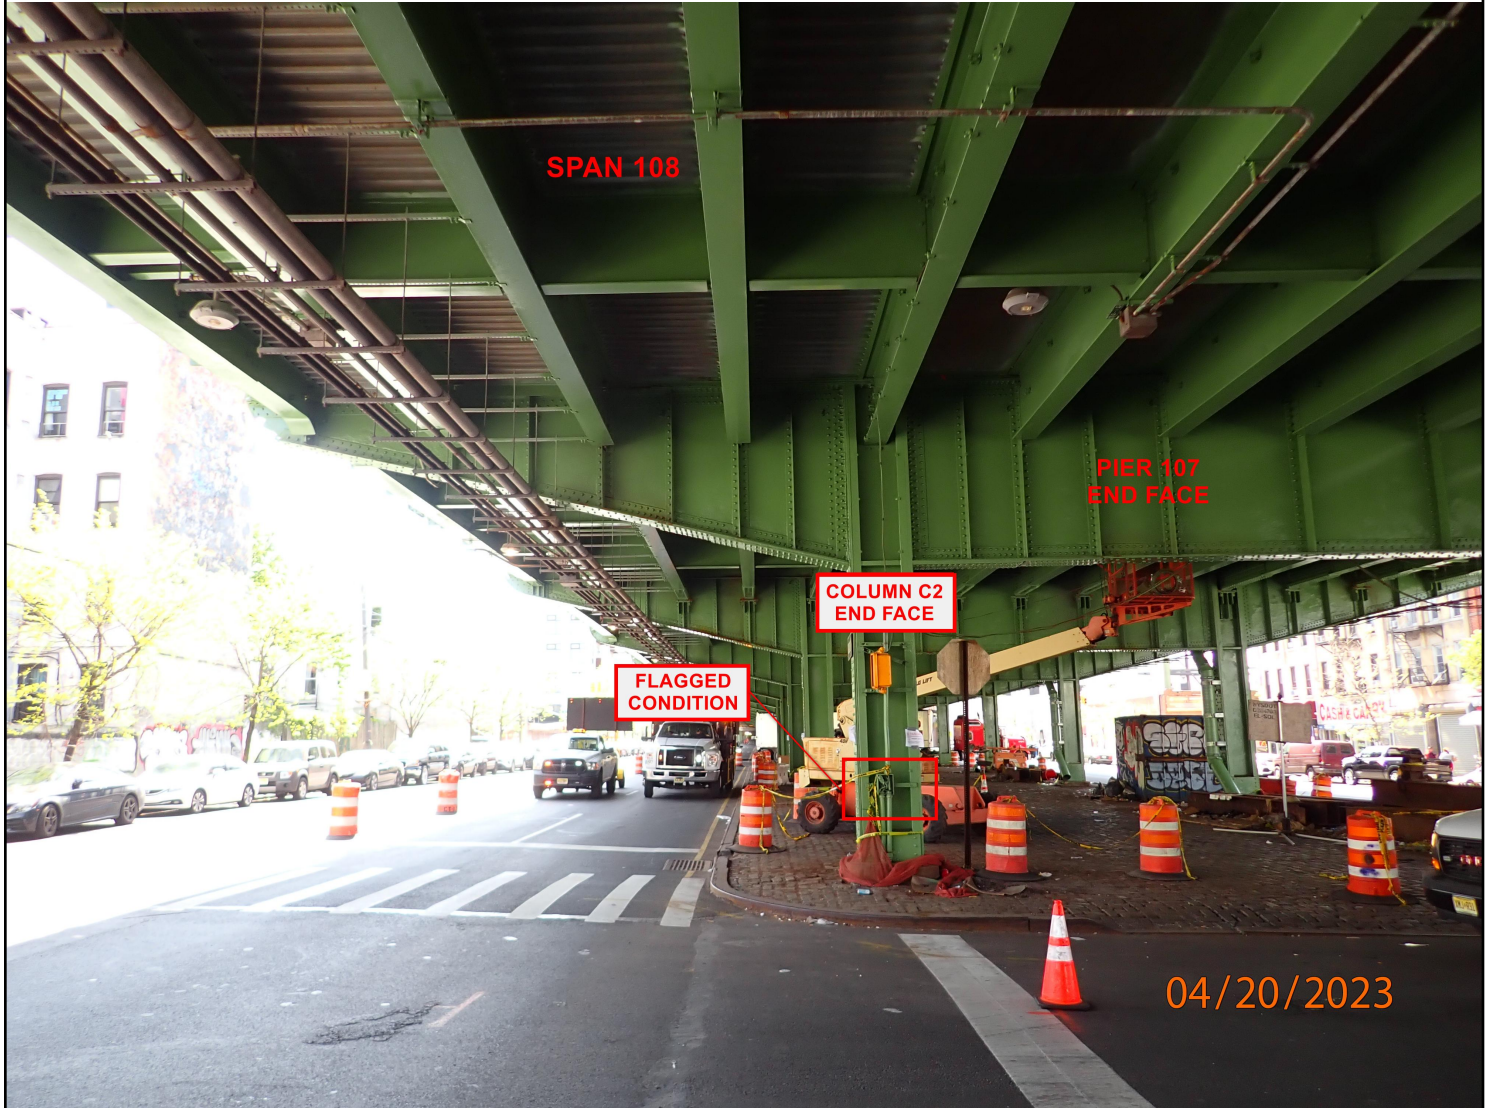
Photo Number: 2

Attachment Description: General view of the flagged condition under Span 108, column C2 at Pier 107. Looking Begin.

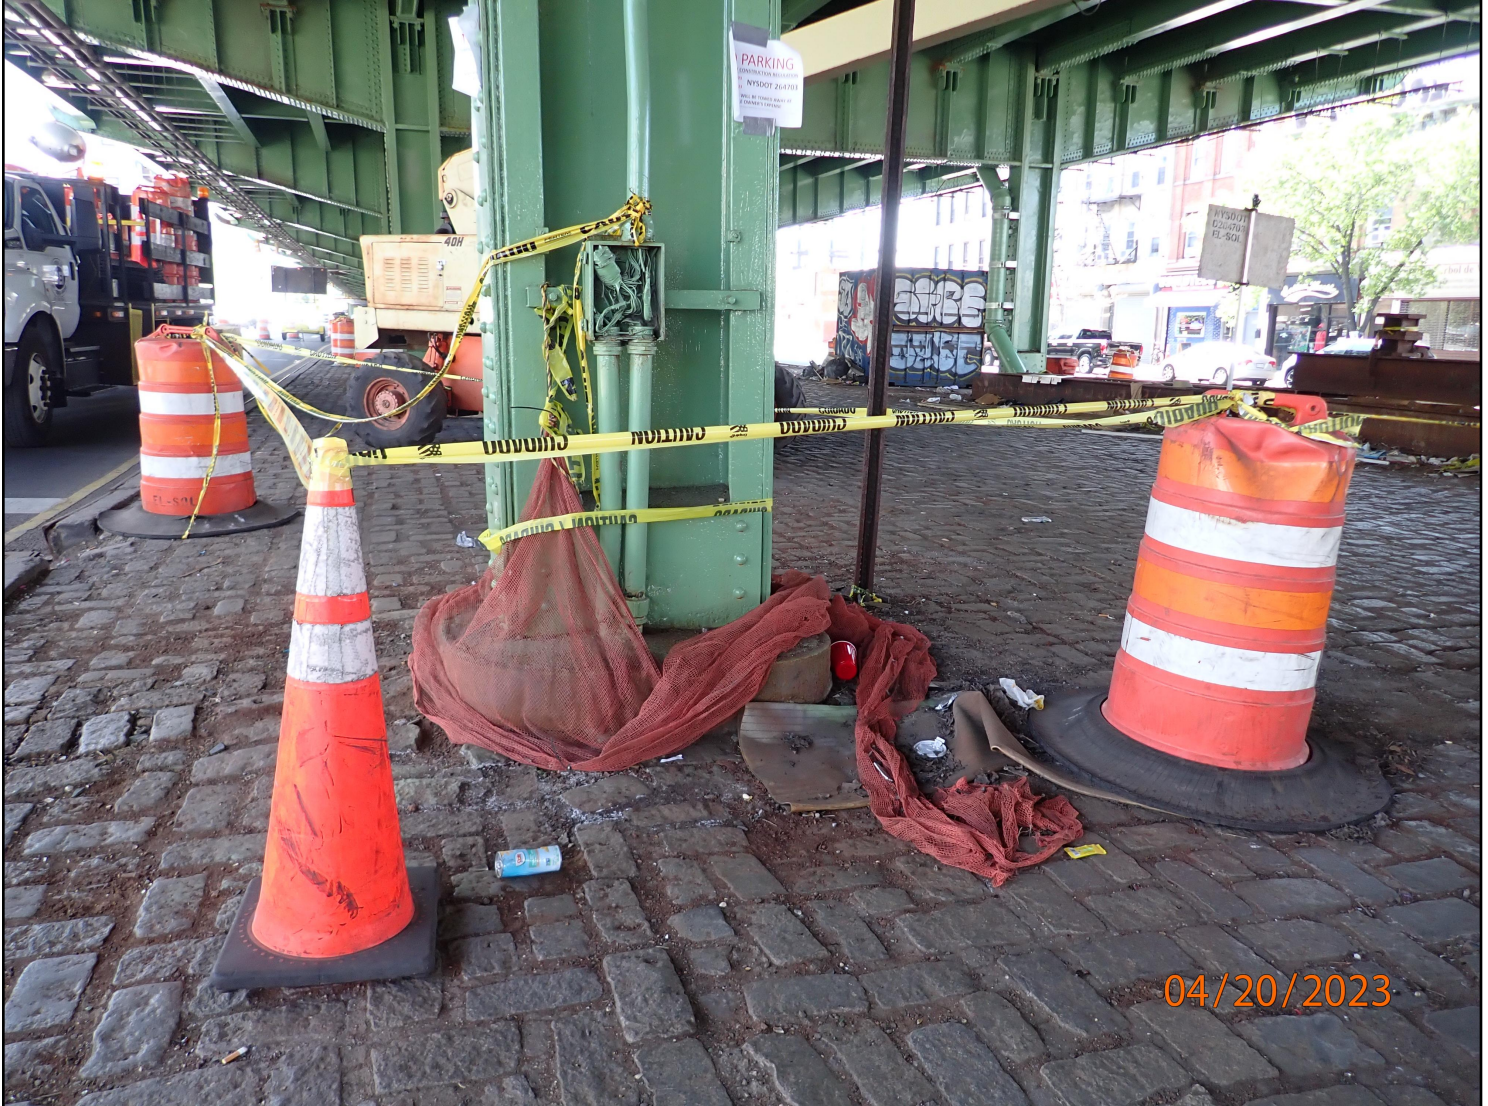
Photo Number: 3

The junction box for the traffic light and attached to Column C2 is broken with exposed electric wires. This location is located at 3' above the ground on the sidewalk and can be accessed by walking. The area is temporarily secured with cones and caution tape.

Attachment Description: The sidewalk at the end face of Column 2 of Pier 107 under Span 108. The electrical junction box is broken with exposed wires. The area has been coned off with yellow caution tape. Looking Begin.

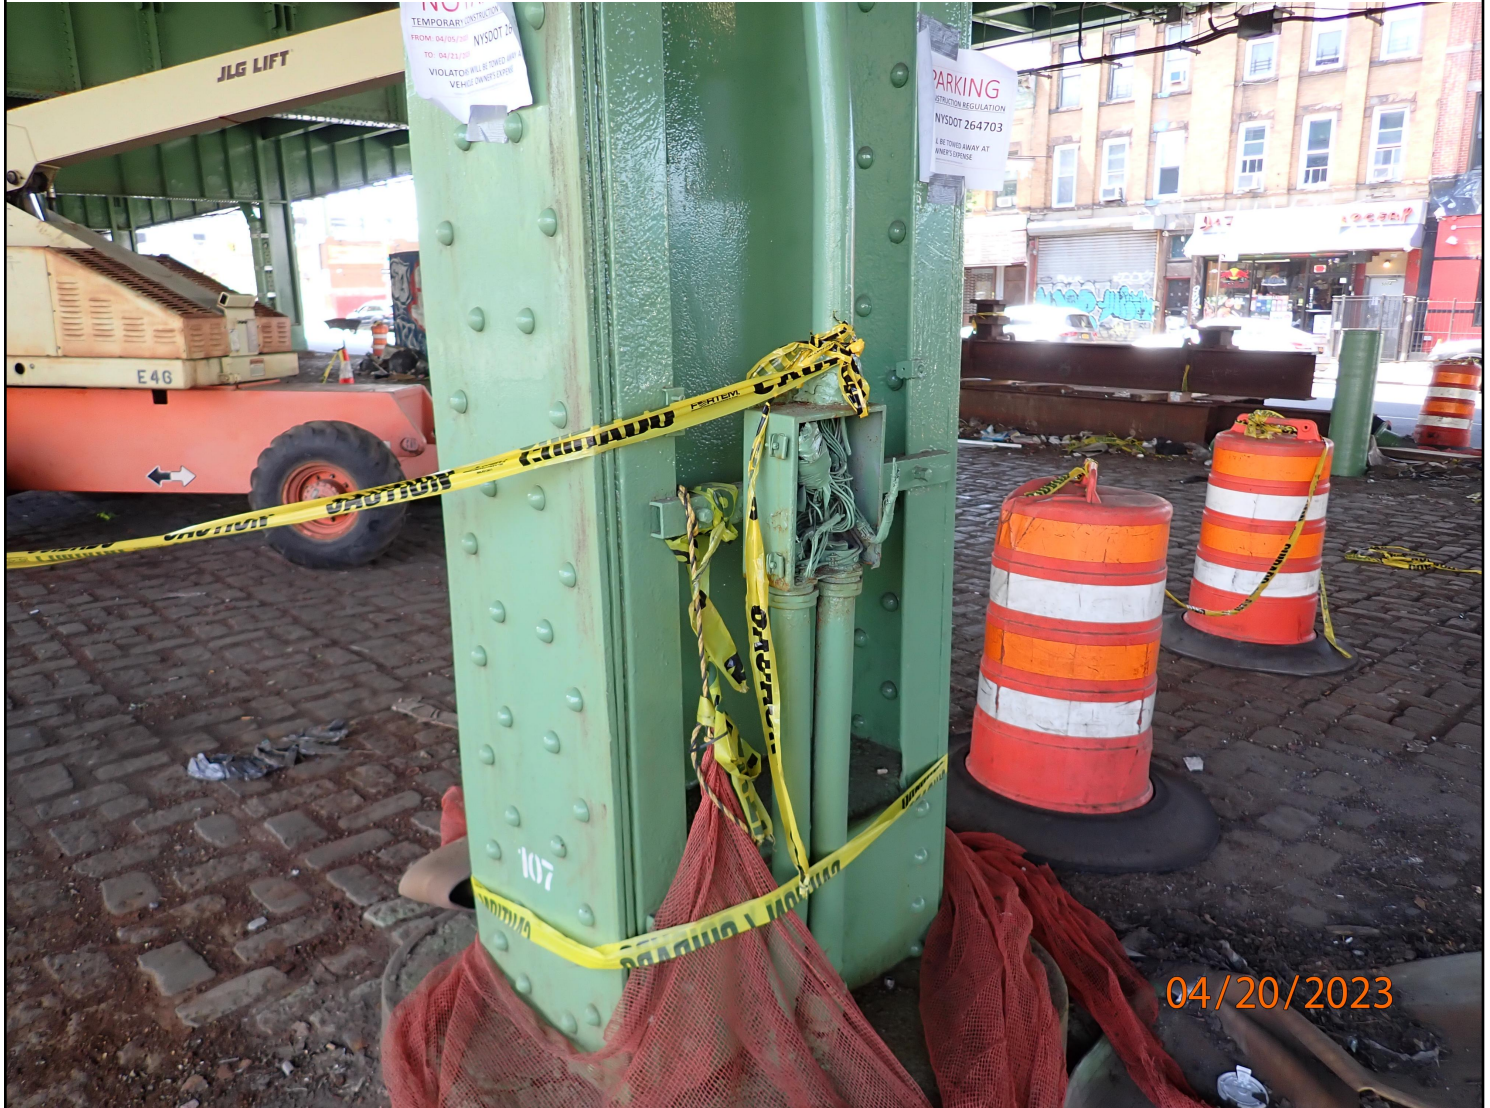
Photo Number: 4

Attachment Description: The sidewalk at the end face of Column 2 of Pier 107 under Span 108. The electrical junction box is broken with exposed wires. The area has been coned off with yellow caution tape. Looking Begin-Left.

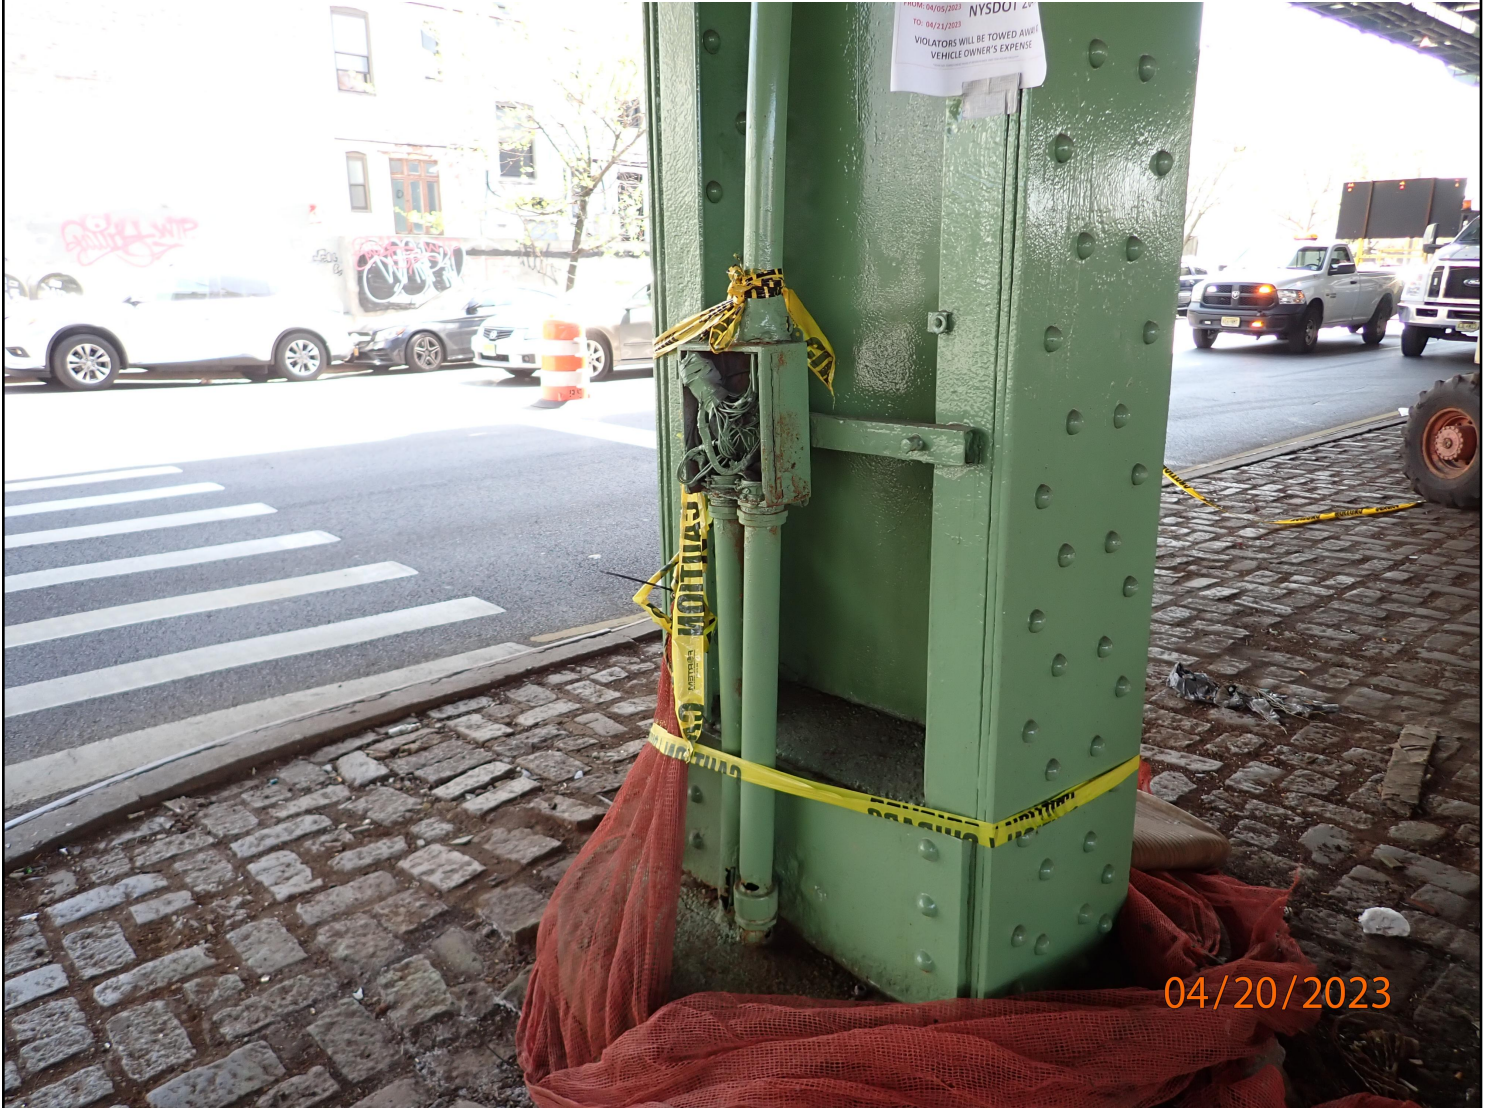
Photo Number: 5

Attachment Description: The sidewalk at the end face of Column 2 of Pier 107 under Span 108. The electrical junction box is broken with exposed wires. The area has been coned off with yellow caution tape. Looking Begin-Right.
